CLASSIFICATION		SECRET		25X 25X
COUNTRY	Czechoslovakia	REPORT NO.		
TOPIC	1. Pillbox Construction in Ruzomberok.			
	2. Security Detachments on the Zilina - Ruzomberok Railroad Line.			
25X1X EVALUATION		PLACE OBTAINED		25X1C
25X1C DATE OF CONTENT				
DATE OBTAINED		DATE PREPARED	14 December 1953	
25X1A REFERENCES				
PAGES	3	ENCLOSURES (NO. & TYPE)		
REMARKS				
25X1X

Location Sketch of the Concrete Pillbox in Ruzomberok

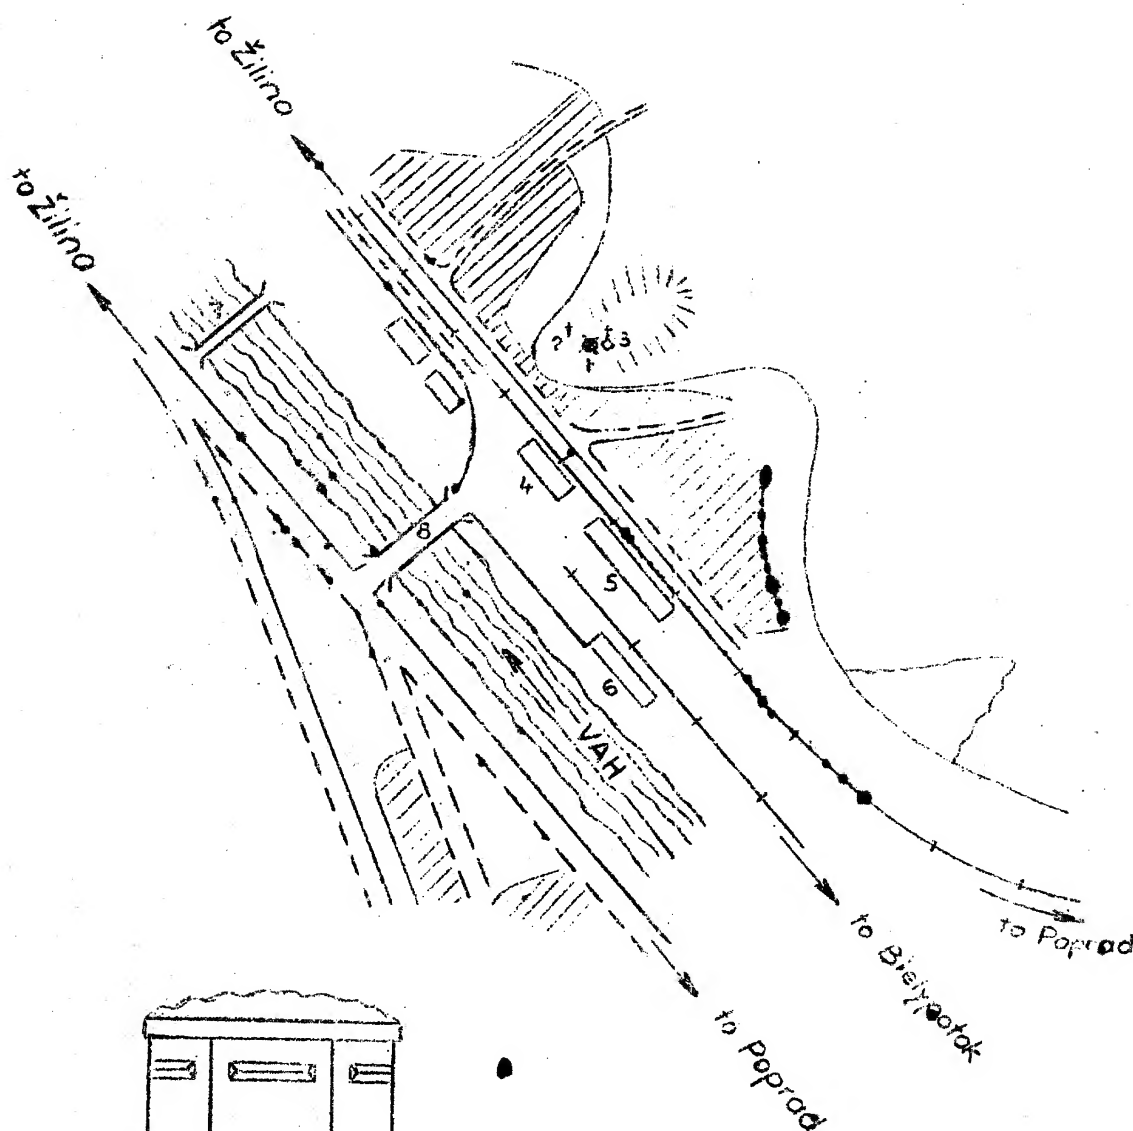
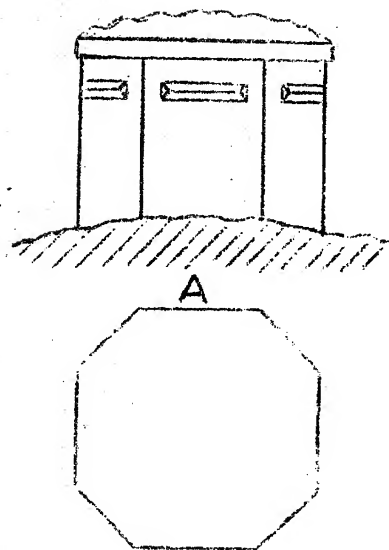
Location Sketch of the Concrete Pillbox in Ruzomberok.

- On 10 October 1953, an octagonal concrete pillbox was under construction on the Cavalry Hill northwest of the Ruzomberok (Q 50/C 99) railroad station close to the chapel. The hill commanded the town area of Ruzomberok, the railroad station, the bridges over the Vah River and a fairly long section of the Zilina (Q 50/O 92) - Kosice (R 49/E 34) double-track railroad line. The pillbox, which was worked on by two construction workers, projected about 1.5 meters from the ground and had a flat roof covered with an earth layer. Each of the visible side walls had a loophole, about 70 cm wide and about 25 cm high, which was about 30 cm beneath the roof.

- 1 Pillbox
 - 2 Cross
 - 3 Chapel
 - 4 Railroad Station
 - 5 Railroad depot
 - 6 Railroad depot
 - 7 Wooden bridge - closed
 - 8 Wooden bridge
- A Projection and horizontal plan of pillbox.
